CANDOR: Achieving rotational tolerances on a polychromatic neutron reflectometer

*Nancy Hadad
NIST Center for Neutron
Research (NCNR)*

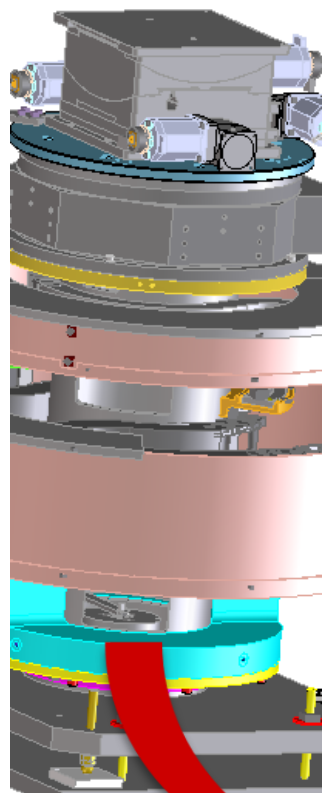
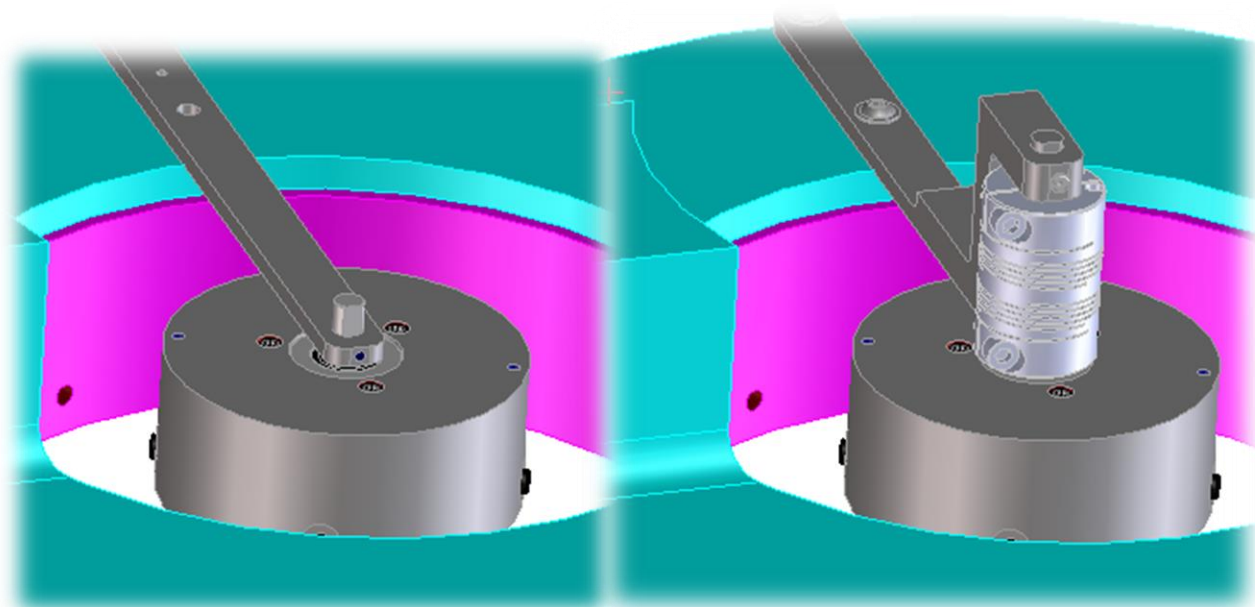
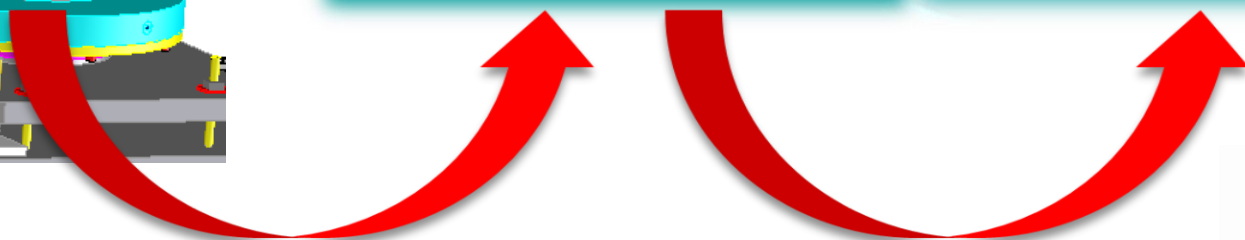
Missing Coupling on Absolute Enc.

- Problem with positioning detector arm
 - Neither the incremental or absolute encoders matched the laser tracker angle
- What is wrong with the Absolute Encoder?

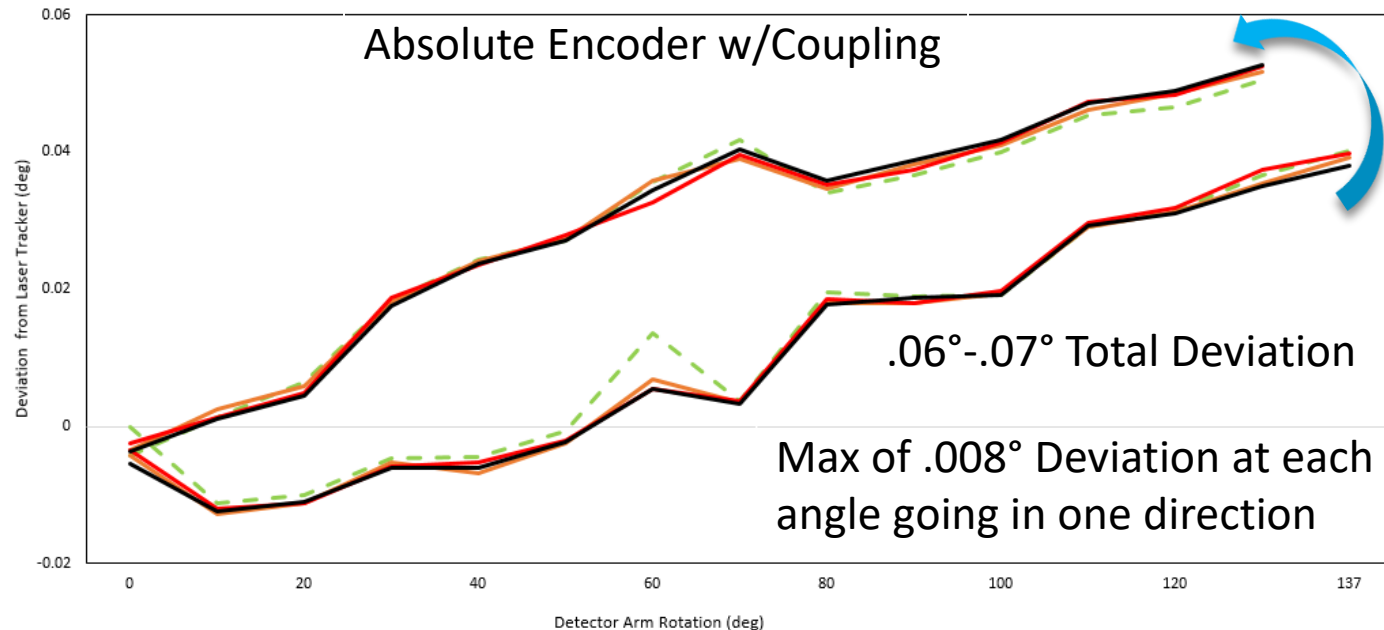
Effects of Adding Coupling

Rotation of Detector Arm – 0-140-0°

- Lookup Table?
- Direction Reversal - Are the outboard wheels aligned to the center of rotation?

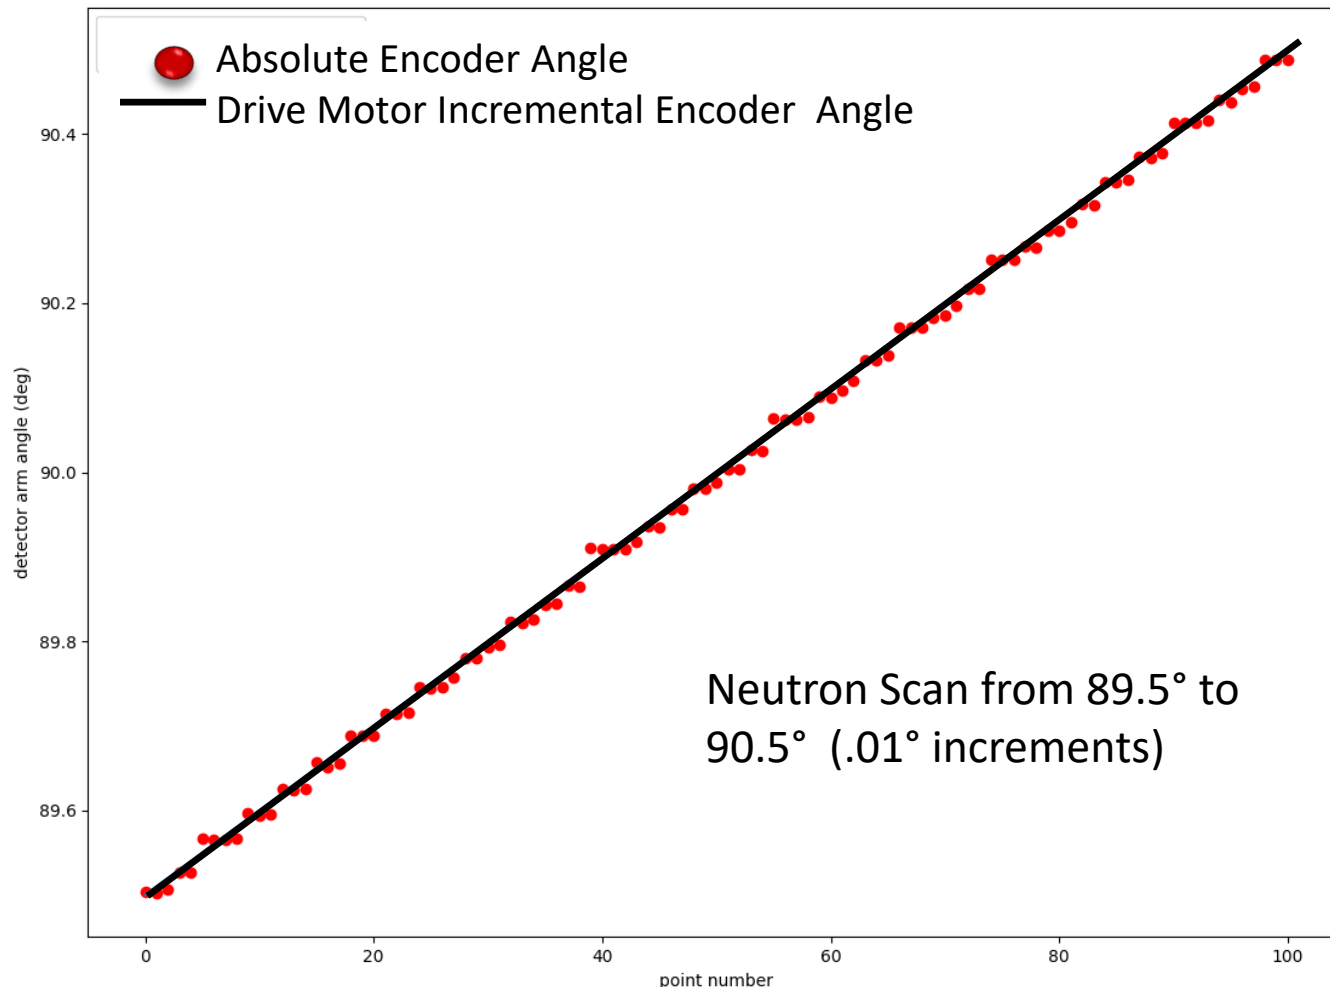
Encoder positions recorded during neutron scan show mismatch

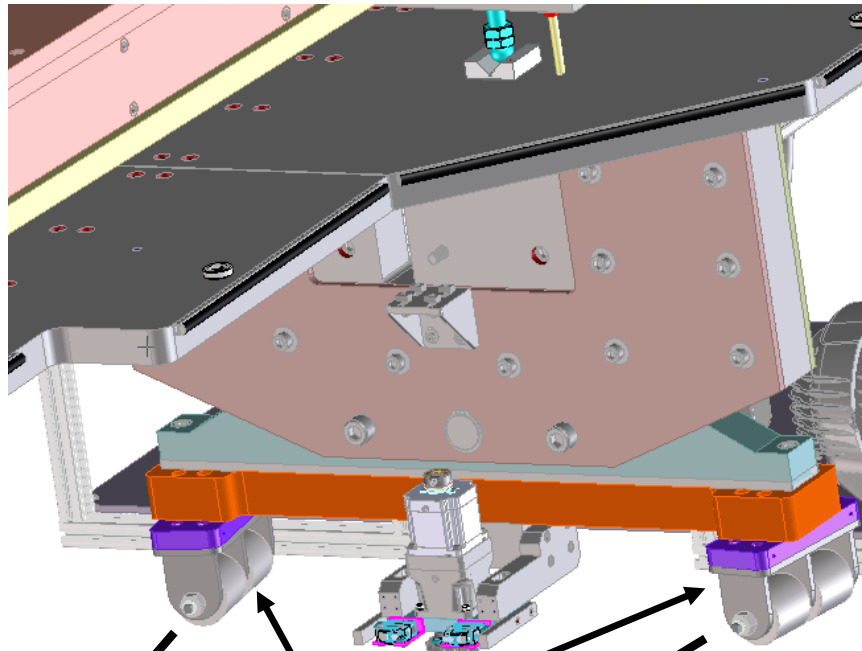
Wheel alignment

- Wheels not aligned on the axis of rotation
 - 2° of back driving in one direction does not fix this
 - Several small neutron scans at 0 degrees enable wheels to relax into a repeatable position after large arm rotations (data available upon request)
- Faulty sprocket engagement with roller chain

Casters

Aligned on Axis
of Rotation?

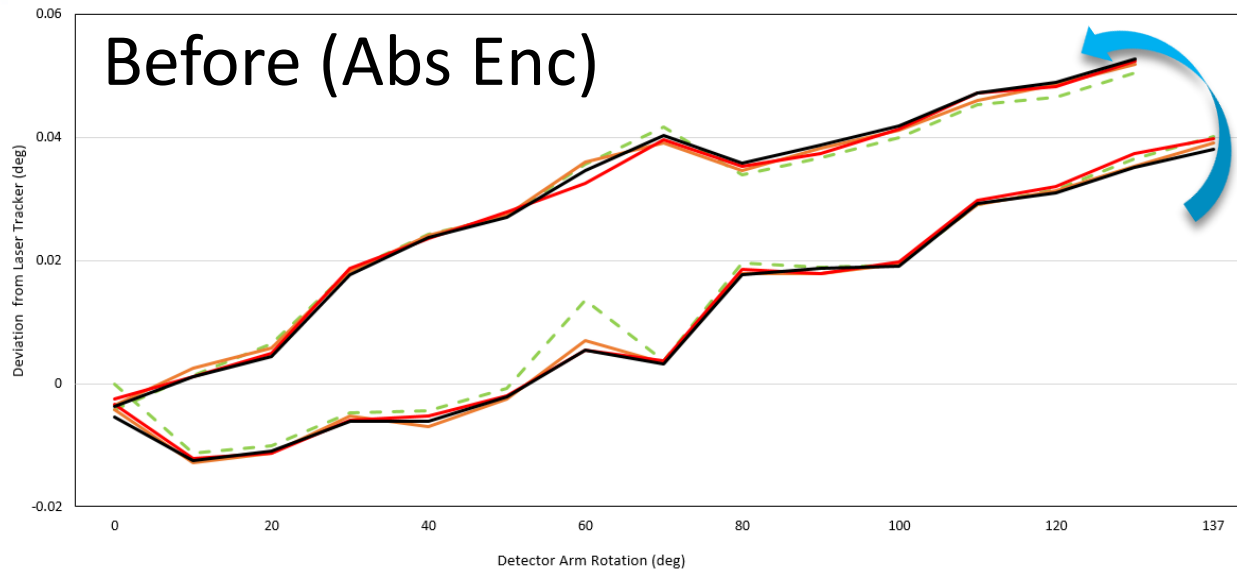
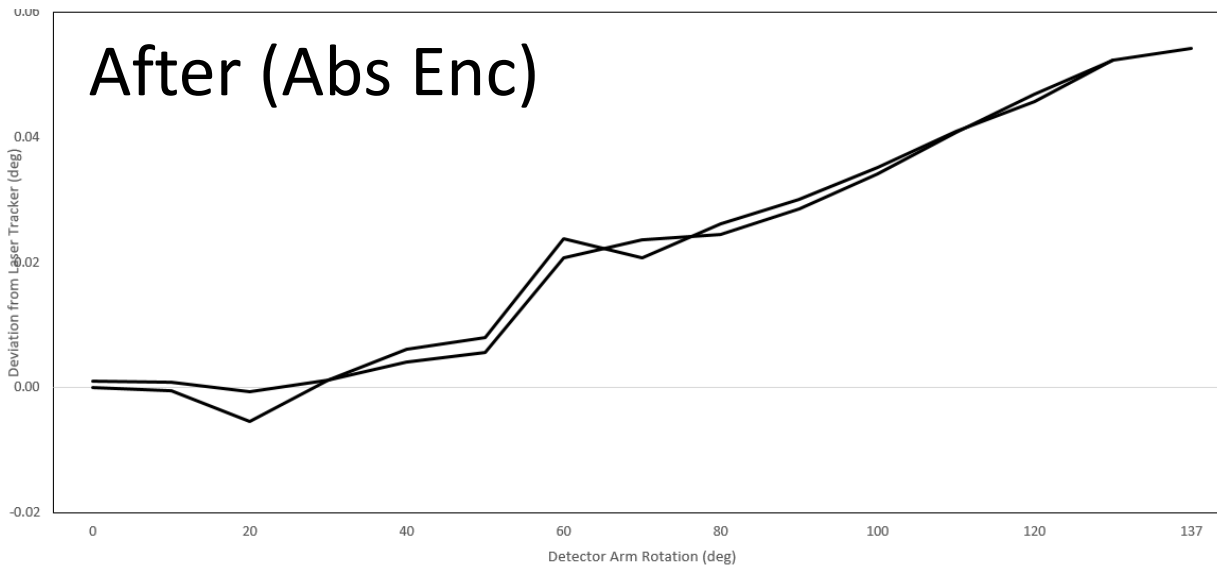
Before & after wheel alignment

Note: Detector Arm Positioned by Drive Motor (not absolute encoder)

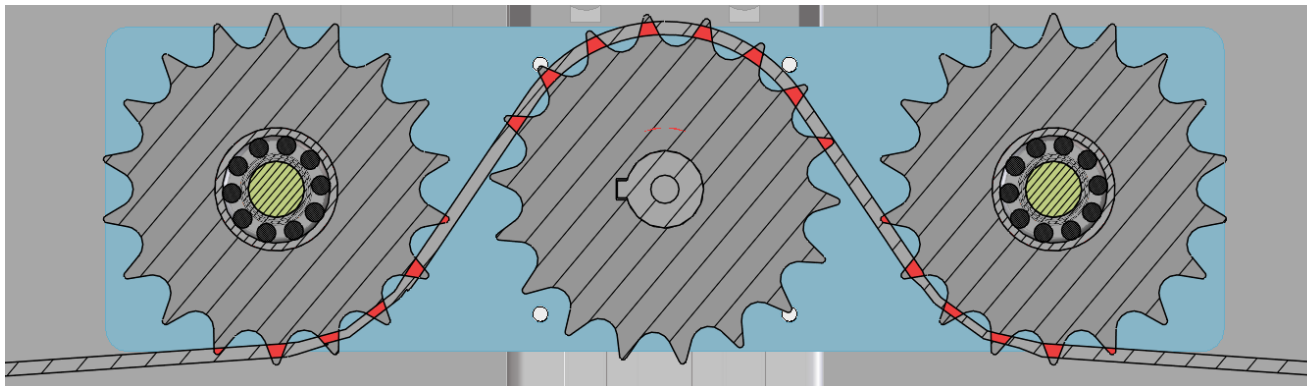
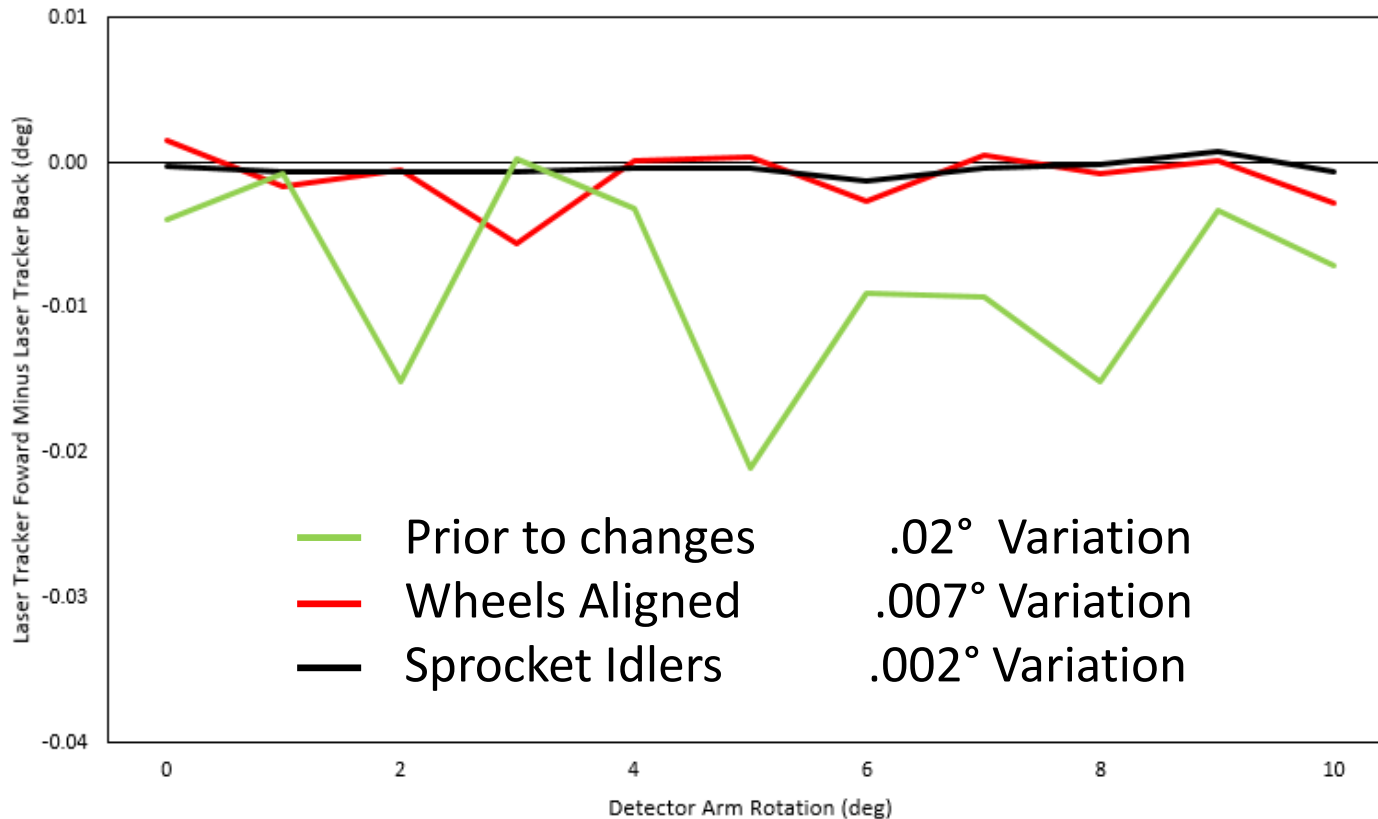
Detector Arm Repeatability – 10x better

Laser Tracker (0-10°) MINUS Laser Tracker (10-0°)

Note: Detector Arm Positioned by Drive Motor
(not absolute encoder)
