Upgrade of KWS1 Polarizer changer for KWS 1

Dr. Romuald Hanslik Forschungszentrum Jülich GmbH ZEA-1

DENIM 2015 Budapest, 07.09.15

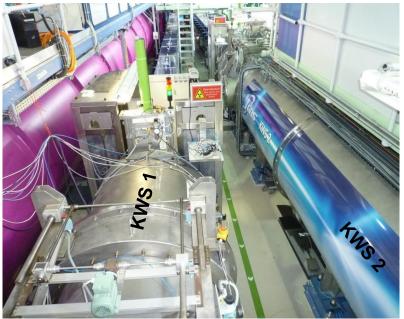
<u>Klein-Winkel-Streuapparatur</u> Small Angle Neutron Scattering Instrument

- Tool to study structures and particles in the nano- to micrometer range in soft matter, material sciences and biology.
- KWS 1 is supplied with cold neutrons from a cold source inside the moderator vessel of the FRMII reactor.

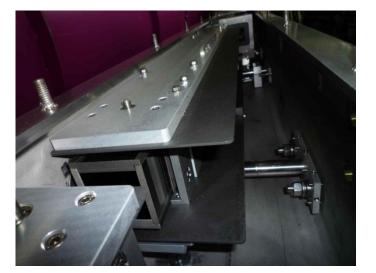
Upgrade of KWS 1 collimation carriages

permanent magnetic field of 15 Gauss

Active apertures

Passive apertures

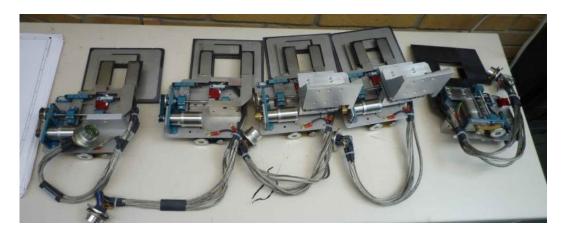
Upgrade of KWS 1 active collimation apertures

active collimation apertures in the Pos. 2m, 8m, 14m, 20m of collimation

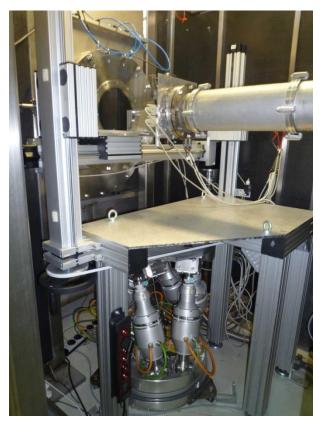
Upgrade of KWS 1 Sample Position

A sample table for conventional SANS experiments and a nonmagnetic hexapod, specially designed to carry heavy magnets, for experiments with magnetic samples.

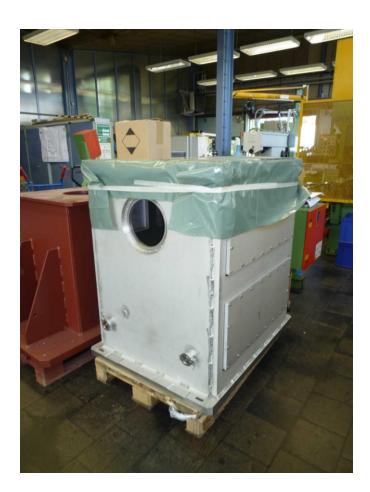
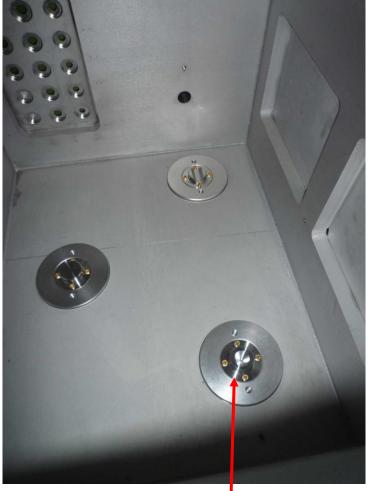
Fabrication of the vacuum chamber

Three supports for the polarizer in the form of cones, spheres and flat support

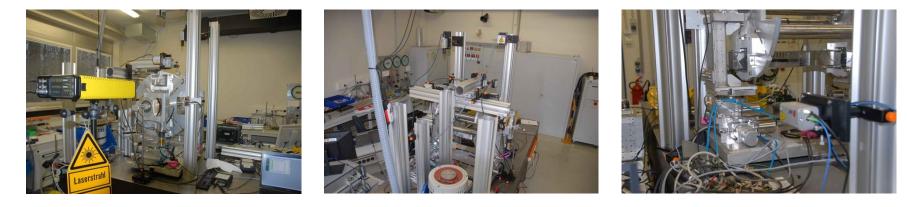
- We have installed the steel bearings. We had success. The repeatability of the changer was significantly better. But this we wanted to check exactly.
- We have decided to build the polarizer changer in our laboratory and precisely to check.
- Our test engineer U. Giesen has built a very complex test stand.

- The operating mode of the changer was optimized
- The sequences of movements were determined
- The moving velocities were optimized
- Because of the knowledge gained and data, automatic program was written by ZEA-2 for the movement of the changer. Thus, each position of polarizer changer can be stored and repeated

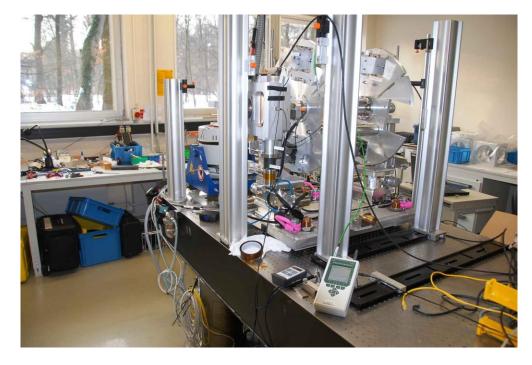
During one of the last measurements we have observed large measurements deviations. The deviations could not be correctly assigned, they occurred arbitrarily.

We have observed the measurements deviations during the standstill of the changer too.

At 100m distance from our laboratory was a construction site with a pneumatic hammer. Our instruments have measured the vibrations from the construction site.

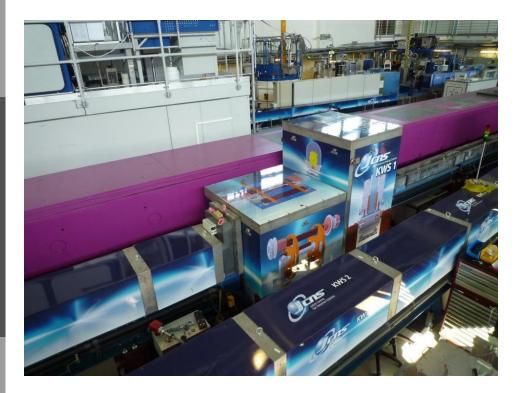
This is the present status of the Chopper and Polarizer changer
